ROCK CUT SLOPE STABILITY EVALUATION OF THE CROCKER FORMATION ALONG JALAN UMS, KOTA KINABALU, SABAH

¹Mohd Muzhafar Mohd Zaki, ¹Sanudin Hj. Tahir,
¹Ismail Abd Rahim, & ²Ahmad Norazhar Mohd Yatim

¹Geology Programme & ²Environmental Science Programme,
School of Sciences and Technology,
Universiti Malaysia Sabah, Jalan UMS, 88400 Kota Kinabalu, Sabah, Malaysia.

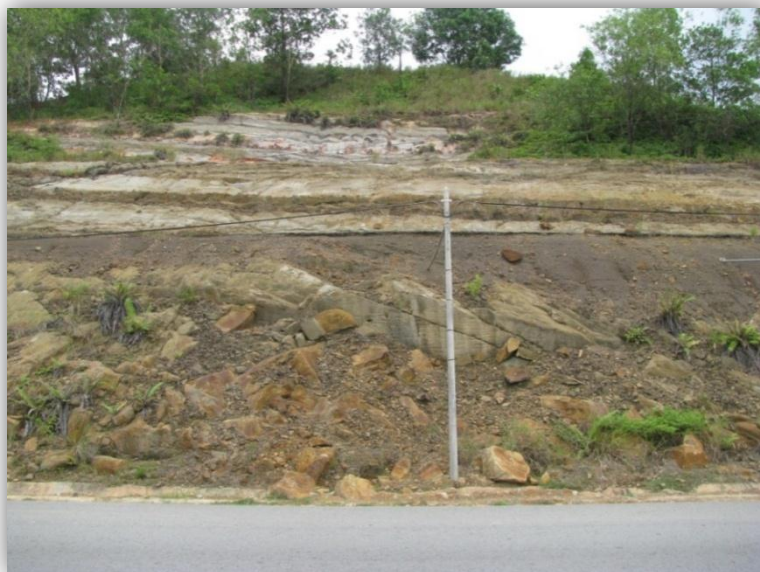
The occurrence of the more than a cubic meter (m³) fallen rock block at the bottom of the cut rock slope at Jalan UMS (Figure 1) has become an issue for this study. To ensure the stability of cut rock slope in this area, an evaluation had to be undertaken. To evaluate the rock slope stability, 10 cut rock slopes along Jalan UMS have been selected and identified as Slope 1, 2, 3, 4, 5, 6, 7, 8, 9 and 10. The locations of cut rock slopes in the study area are shown in Figure 2.

Figure 1. More than a cubic meter (m³) fallen rock block at the bottom of cut rock at Slope 5.

The wedge failure is potential in Slope 5 by the intersection of B and J1 planes. J4 become a release plane for this wedge failure. Intersection of J1 and J2 are contribute to the formation of wedge failure in Slope 6. The release planes are J3 and J4.

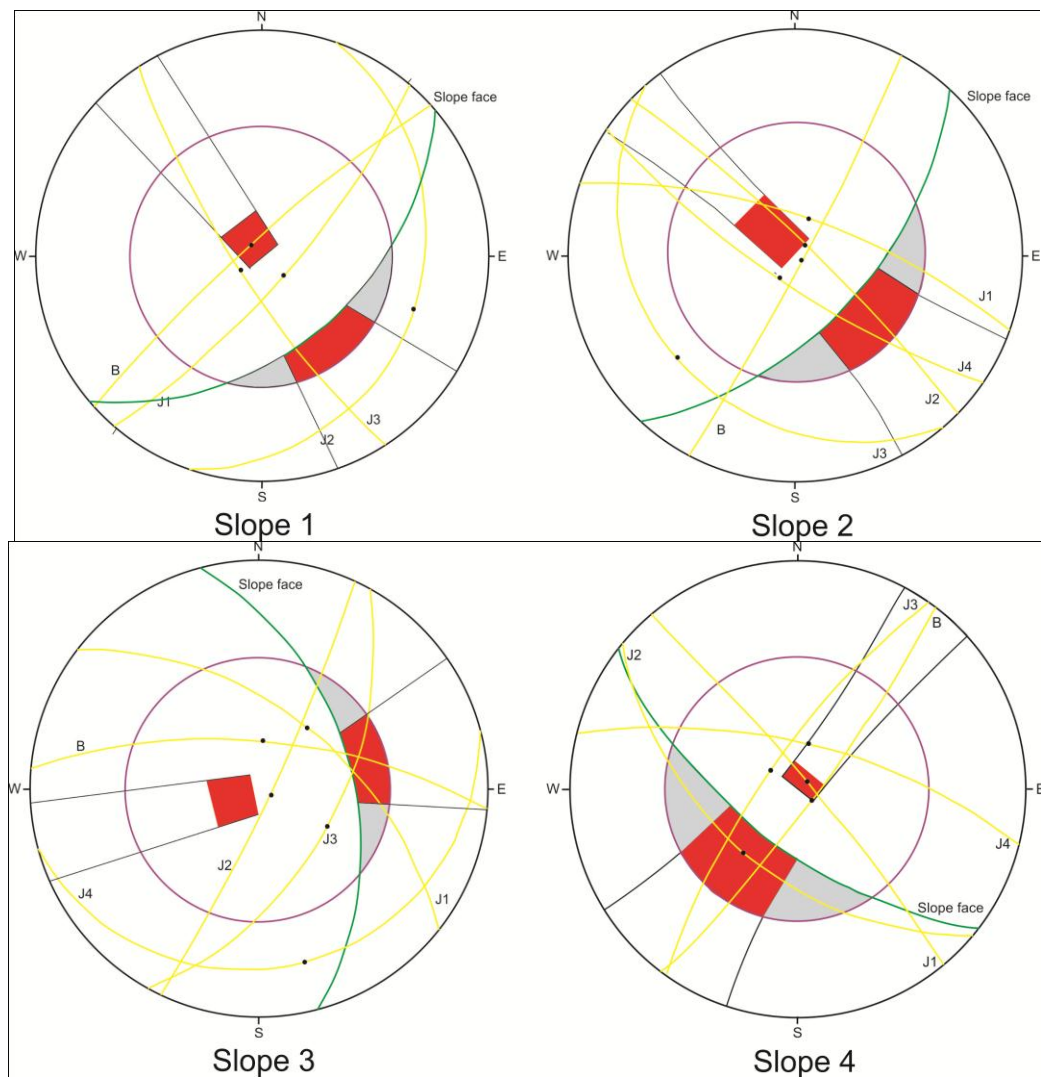
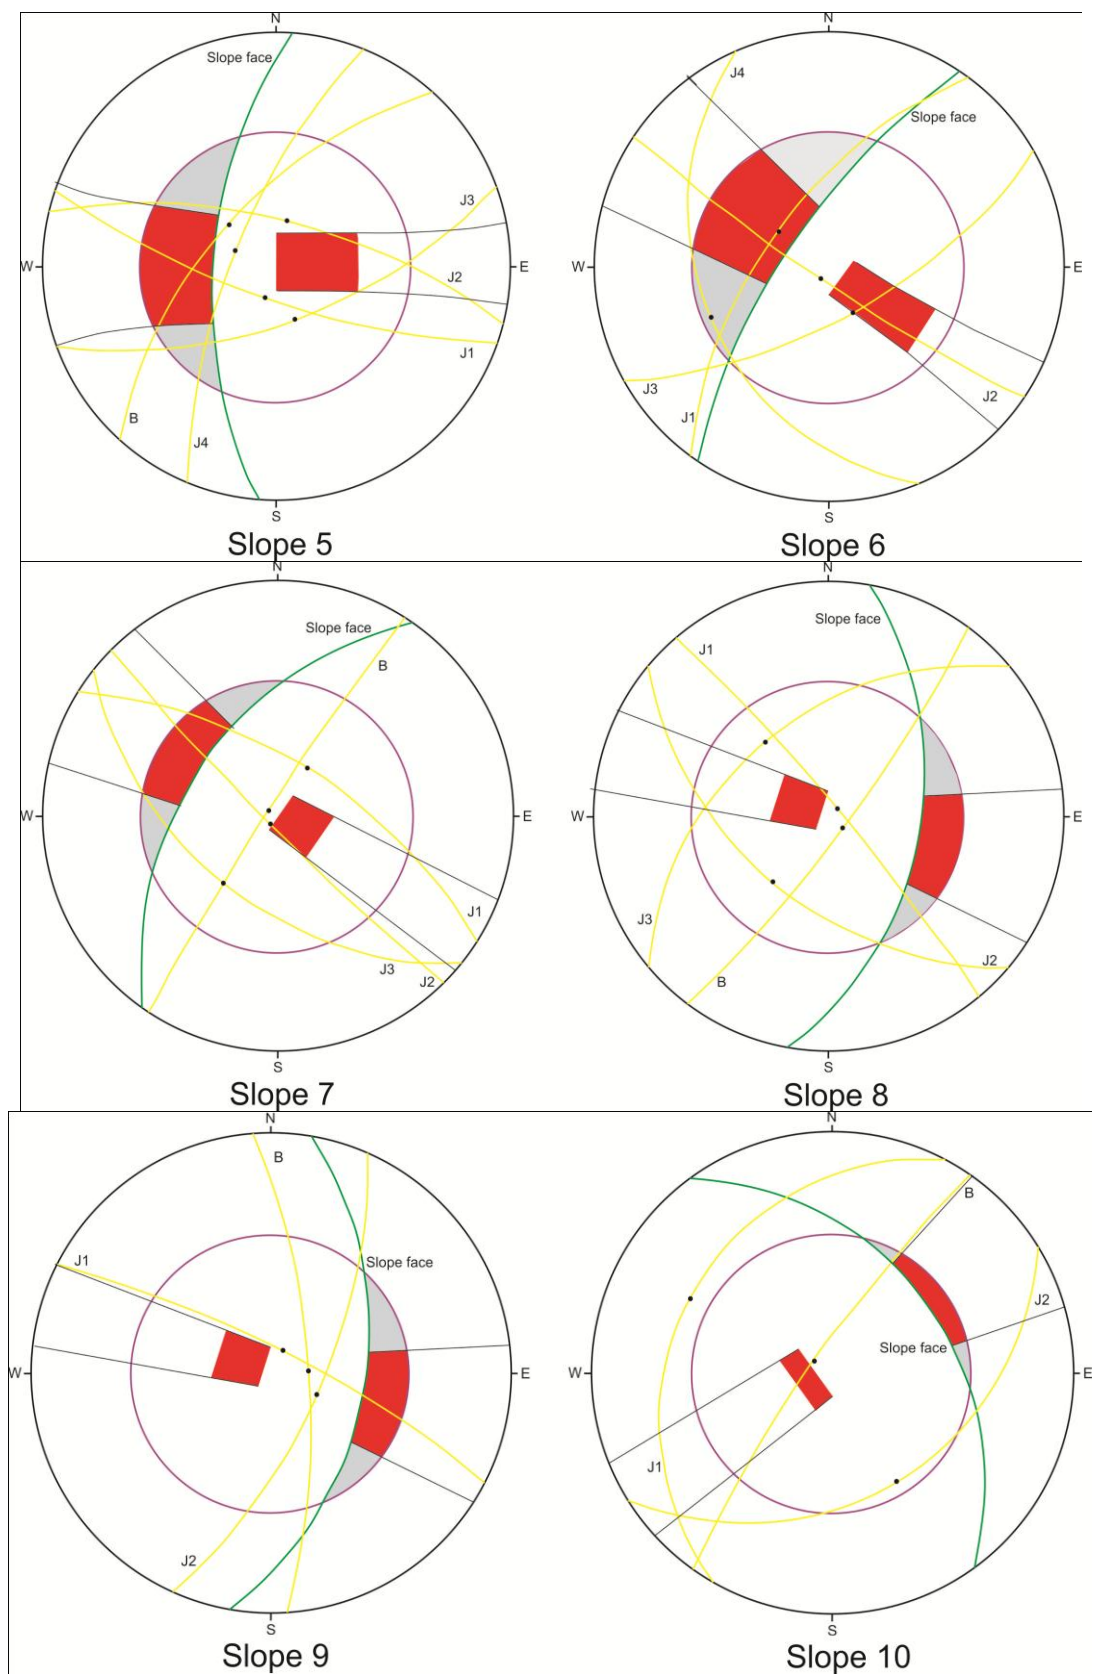
Figure 3. Kinematic analysis of the cut slope at Jalan UMS. Notes: red-potential failure zone; grey-possible failure zone; J1-joint 1; J2-joint 2; J3-joint 3; J4-joint 4; B-bedding.

Figure 3. Kinematic analysis of the cut slope at Jalan UMS. Note; red-potential for failure zone; grey-possible for failure zone; J1-joint 1; J2-joint 2; J3-joint 3; J4-joint 4; B-bedding (con't).

Intersection of J3 with B and J1 in Slope 3 contributes to the formation of wedge failures. J2 and J1 act as release planes for these wedge failures. In Slope 4, wedge failures are formed by the intersection of J2 with J3 and B planes. The release plane in these wedge failures is J1. Planar failure is also potential in this slope because J2 is day lighting on the slope face with the occurrence of J1 as a release plane.

Joint J1 is day lighting in Slope 1 face for toppling failure as well as the occurrence of J1 and J3 release planes. Kinematic analysis shows that there are no potential failure in slope 2, 7, 8, 9 and 10 due to the intersection point and discontinuity planes are not daylight on the slope faces.

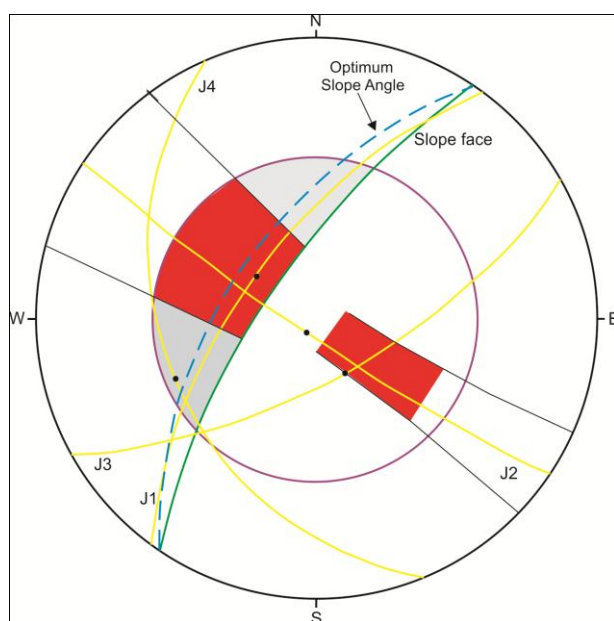
Slope flattening or optimum slope angle was determine by stereographic analysis and one of the example was done for Slope 6 are shown in Figure 4. The result of others slope optimum angle are shown in Table 2. The overall optimum slope angles vary between 30° and 55°.

Figure 4. Optimum Slope Angle (example Slope 6).

Wire mesh and drainage ditch are also recommended remedial measures for the cut rock slopes in the study area (Table 2).
