SURVEY OF SLOPE FAILURES (SFS) ALONG THE BUNDU TUHAN KUNDASANG HIGHWAY, SABAH, MALAYSIA

Rodeano Roslee, Sanudin Tahir, S. Abd. Kadir S. Omang & Adong Laming

ABSTRACT. *This study focused on the slope failures survey (SFS) along the Bundu Tuhan - Kundasang highway, which is one of the most vulnerable areas to slope failures in west coast of Sabah. The area is underlain the Trusmi Formation (Palaeocene to Eocene age), the Crocker Formation (Late Eocene to Early Miocene age) and Quaternary Alluvium Deposits. These geologic units are dissected by numerous lineaments and structural styles produced by complex tectonic history of multi phase deformations. The tectonic complexity reduces the physical and mechanical properties of the rocks and soils; and produced intensive displacements in substrata, resulting in intensive high degree of weathering processes and instability. In this study, a total of 50 selected critical slopes were studied. This study classified the slope failures into three main groups: soil slope failures, rock slope failures and erosional failures. Failures in soil slopes (including embankments) total 34 (68 %) with 10 failures (20 %) of rock slopes and 6 failures (12

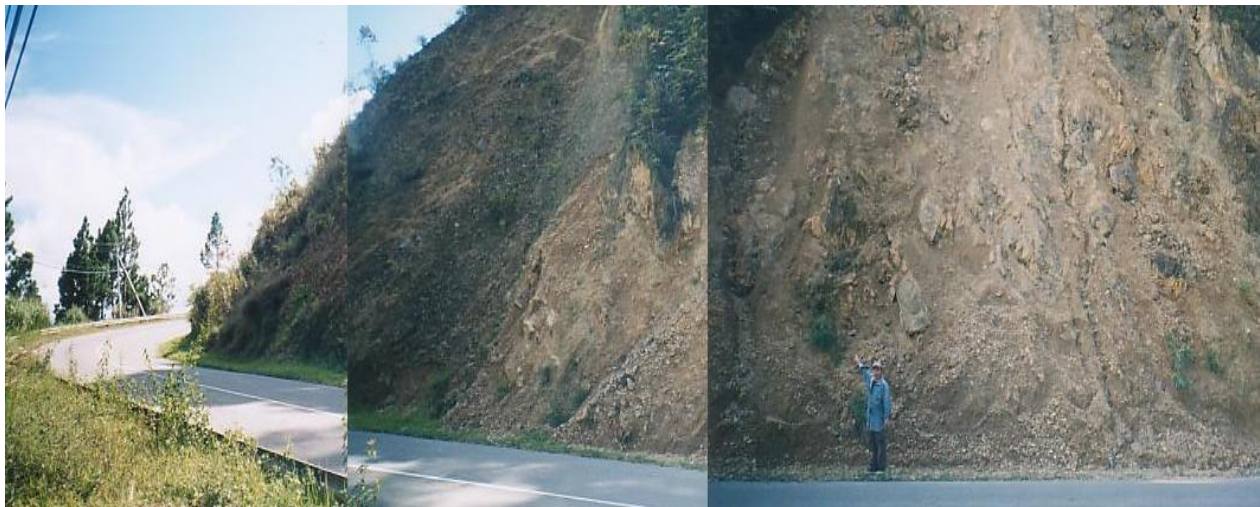
Table 3 shows the results of a detailed analysis of rock slope failures. Although rock slope failures contributed only 20 % (10 failures) of the total failures, they involved large volume of rock weathered (Figure 6). The main factor contributing to rock slope failures was the orientation and intensity of discontinuity planes. That is why rock slope failures occurred most frequently along the highway on sedimentary rocks, which were highly breccias and fractured. About 90 % of the rock slope failures occur in sedimentary rocks of Trusmadi Formation and Crocker Formation while the remaining 10 % occurrences in metasedimentary rocks of Trusmadi Formation. Generally the failed material underwent only moderate to complete weathering (grade III, IV and V). Other factors contributing to slope failures were the presence of groundwater, climatological setting, joints filling material, high degree of rock fracturing due to shearing in shear, steep of slope angle, high intensive of faulting and folding activities, locating at the fault zones area and design negligence.

Figure 6. Fall and blocks (B4 – a) at East KM 87.30 (L19) shows the form of discontinuities provides intersecting sheets to form yield stepped surfaces or boundary vertical joints

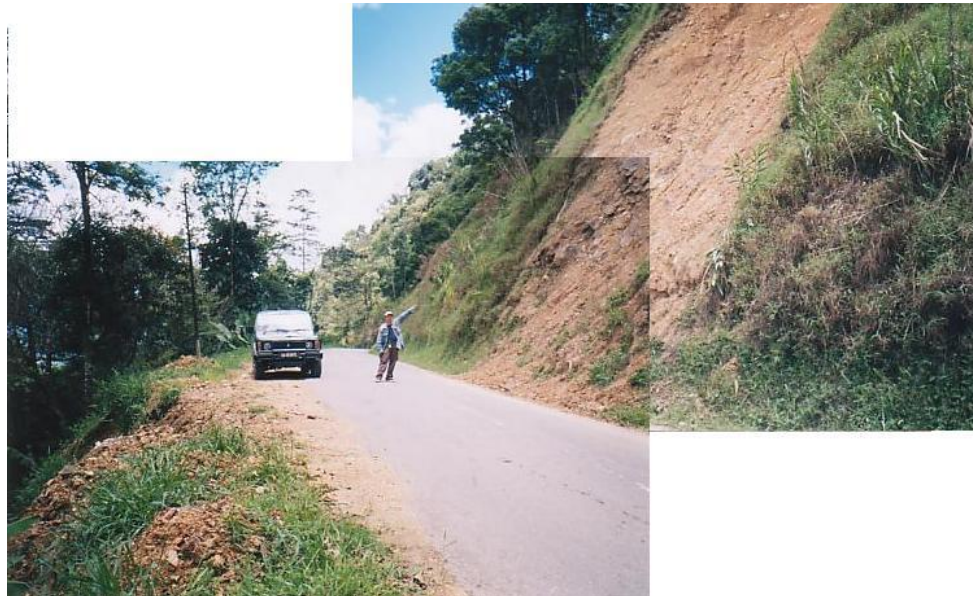
Results of a detailed analysis of soil slope failures are presented in Table 4. Considering cut slopes, all the major lithologies are involved showing that this type of failure is not mostly controlled by lithology. The failure volume scale involved generally small to large in size possibly endangering road users. In term of weathering grades, the materials that underwent failure were in the ranges from grade IV to VI (Figures 7 to 9). Weathering is the main factor causing failure with the depth of weathering influencing the volume of material that fails. It appears that grade IV and grade V materials actually failed with the overlying grade VI material sliding or slumping down together with this material during failure. The presence of ground water, slope angle, removal of vegetation cover, lack of proper drainage system, artificial changing, climatological setting, geological characteristics and material characteristics are additional factors contributing to the failures. Failures of embankments always involve large volume scale and often resulted in the partial or entire destruction of the highway. It appeared the improper construction is the main factor leading to failure. In many cases, the slope angle, removal of vegetation cover, overburden or vibration from vehicles, climatological setting, geological characteristics and material characteristics contributed to failure. As many of the embankments were across in valleys, insufficient the embankment

slopes caused the failure. It was also observed that the failure plane surface occurred on the interface between in-situ highly weathered rock and residual soil, debris and embankment material.

Figure 7. Shallow slide (T1 – a) at South KM 87.80 (L13 & L14) shows the failure movement are starting to move into several discrete blocks through the development of transverse cracks

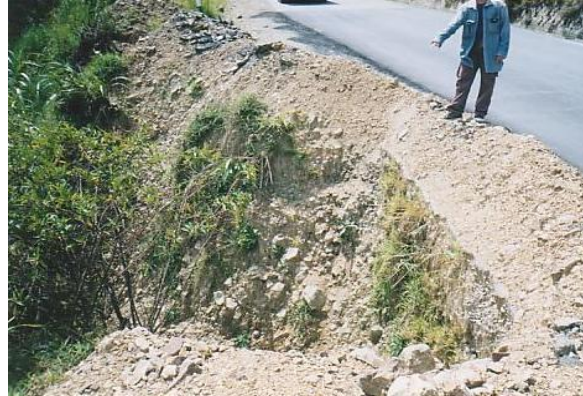
Figure 8. Embankment failure in the form of a deep slide (T1 – b) at East KM 84.00 (L1)

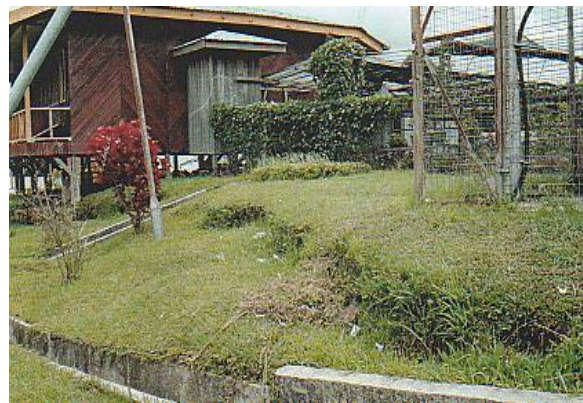
Figure 9. Creep (T4) at North KM 95.80 (L41) often display complex cracks pattern. All of the cracks are capable of becoming residual weakness after this type of failure had ceased to move

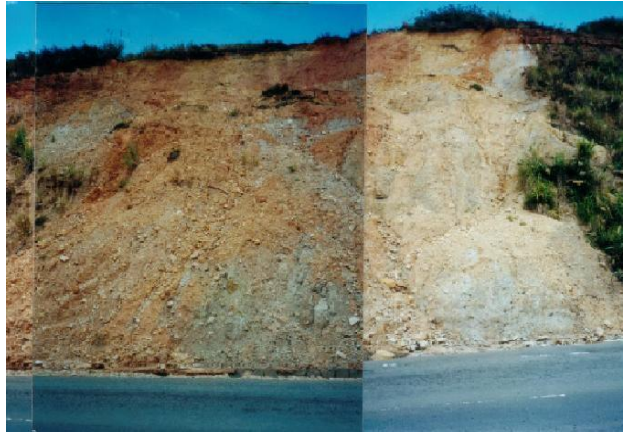
Erosional failures are mainly small to large scale and are caused by high volumes of running water and the condition of the materials due to weathering process (Figures 10, 11 and Table 5). Erosional failures occur most frequently on clayey loamy of residual soil materials of the slope, mainly because of the thick and well developed grade IV to V layers of the weathering profile. These clayey loamy materials have high clay fractions and are generally cohesion. When erosion of IV to V occurs, the overlying grade VI is also transported away.

Figure 10. Erosional failure (gully erosion) (TB1 – b) often associated with human made tip and spoil heaps, although it occurred in rock debris of geological origin (Location: L50 at East KM 96.10)

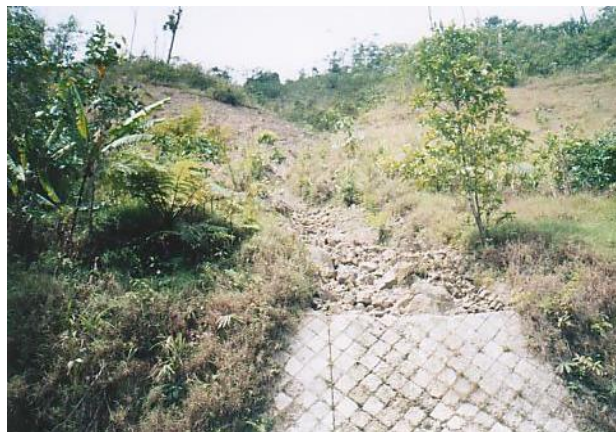
Figure 11. Erosional failure (sheet erosion) (TB1 – a) tend to flow follow shallow depressions and then to spread out into a flat, bulbous fan or even a thin sheet when they reach low ground (Location: L2 at East KM 84.00)
