**THE 2011 ZEN GARDEN LANDSLIDES: TRIGGER AND CAUSAL FACTORS**

**ABSTRACT:** *The Zen Garden Resort and its surrounding area are part of the “Kundasang Landslide Complex” and were experiencing reactivation of old landslides on 10 April 2011. Consequently, more than 80 room units of the resort, ten buildings, homes, and local roads were destroyed, uplifted, and damaged as well as disrupted day traffic. About 500m in length and 200m in width of the slope area were slides for 25m. The vertical fall movement in the head section of the landslide is 25m. There is no direct relationship between the 2015 Ranau earthquake and with earlier rotational clay slide of the 2011 Zen Garden Resort landslide. The causing and triggering factor for landslides are generally varied and are always characterized as region-specific and site-specific. Thus, this study was conducted to unravel the triggering and causal factors for the rotational clay slide of the 2011 Zen Garden Resort landslide. The methodology consists of desk study, remote sensing study, geological mapping, geodynamic mapping, laboratory, and data analysis. This study found that the landslides were triggered by prolonged moderate to occa

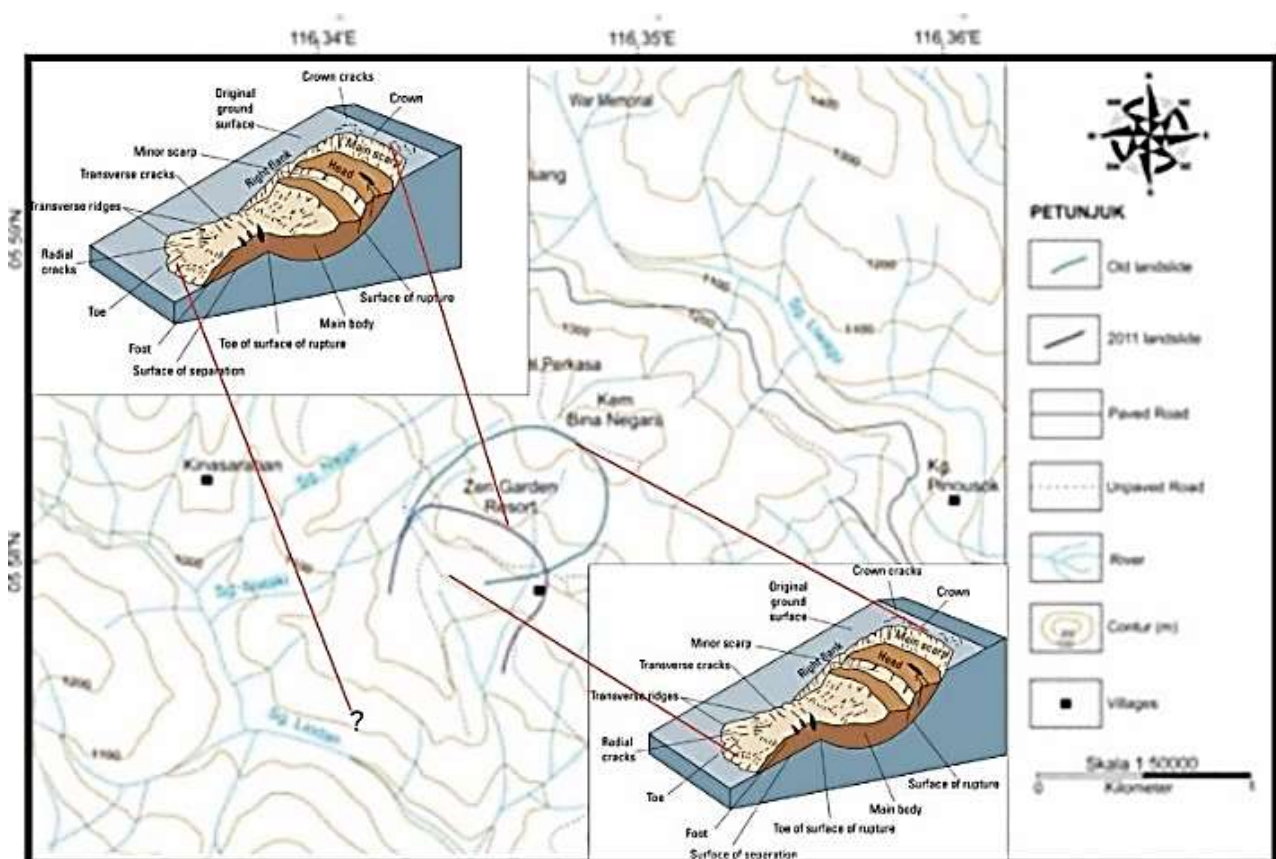
Typical landslide morphology is shown in Figure 3 which is divided into head, body, foot, and toe sections. This landslide is the reactivation of an old dormant landslide (Figure 3) and classified as a rotational clay slide (Hunger et al., 2014). The movement was involving a rotational slide. The materials are colluvium deposits which come from the old landslide and are dominated by matrix material. Then, the slope materials are classified as clay.

**Figure 3** Location and the reactivation on the body (transverse crack) of old landslides. Upper left- old landslide morphology; Lower right- rotational clay slide of the Zen Garden 2011.

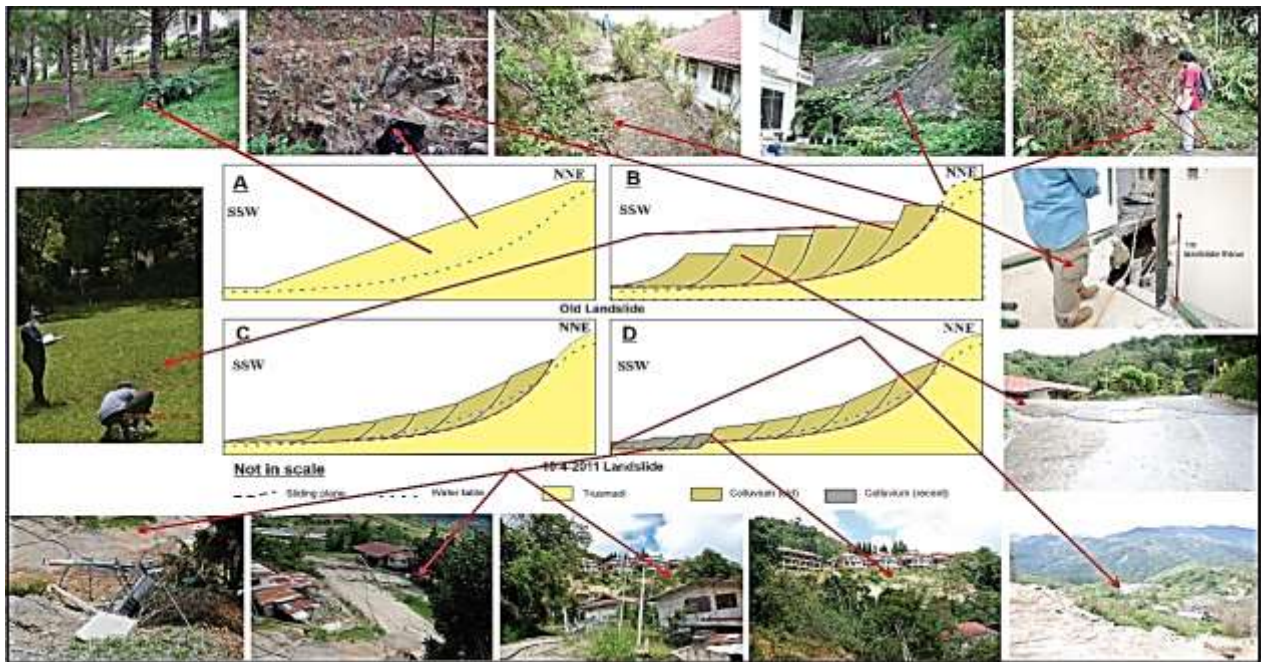
Figure 4 shows the chronology of the formation of a rotational clay slide of the 2011 Zen Garden Resort landslide:

A. Natural slope and water table in the Zen Garden Resort area. The slope has been undergoing natural slope equilibrium proses.

B. The morphology of the old Zen Garden landslide but the upper boundary is not found in field investigation and remote sensing study. Interview with surrounding local was made to collect the data. The transverse crack, major and minor scarp, tension crack, 1m down-thrown surface level, undulating resort road, and colluvium deposit of the old landslide are shown in the Photos in Figure 4.

C. Weathering and erosional processes on the slope surface produce smoother slopes but raise the water table. Surface levelling and fertility of secondary plant shows the natural erosional activity, infiltration, and existence of colluvium deposits from an old landslide.

D. After 20 years, the slope becomes smoother due to the natural phenomenon of slope equilibrium. The slide comes once again but moves its position towards the southern part of the study area. The rotational clay slide of the 2011 Zen Garden Resort landslide took place on the transverse crack of the body section of the old dormant landslide. This landslide is caused by about 200 m width, 450 m length, more than 20 m vertical fall, and tens of meter area thrown down the slope as well as the destruction of more than 80 room units, damages of few buildings, roads, homes and a day traffic disruption. The main scarp, tension crack, transverse crack and foot section are clearly shown in the attached Photos in Figure 4.

**Figure 4** The rotational clay slide of the 2011 Zen Garden Resort Landslide model and the reactivation on the body (transverse crack) of old landslides with attached photos for the selected landslide section. A- Natural slope surface; B- Old landslide mechanism; C- towards natural slope equilibrium; D- rotational clay slide of the 2011 Zen Garden landslide.

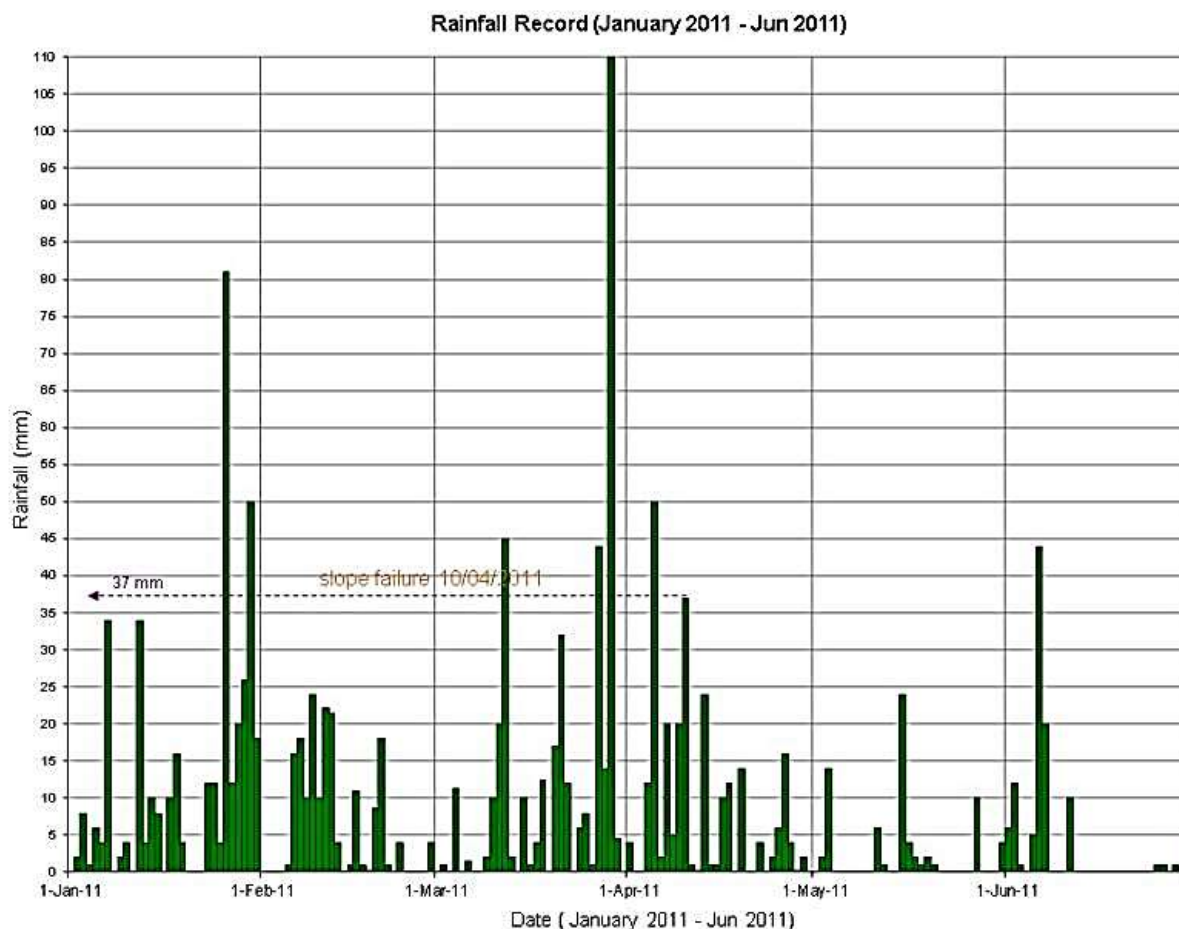
The annual rainfall for the Kundasang area is 2440 mm on average and experienced prolonged light rain type (5-20 mm/days) or moderate with occasional heavy rainfall from January to June 2011. The landslides on 10 April 2011 occurred in only 37mm of rainfall but occasional intense rainfall (until 110 mm/day) happened before (Figure 5). That prolonged moderate to occasional heavy rainfall will raise groundwater level rapidly condition to the ground surface and this would result in a sudden increase in pore pressure which would reduce the shearing resistance of geomaterial and finally lead to a failure or landslide.

**Figure 5** Daily rainfall record from January to June 2011 in the Kundasang area (source from IKRAM, 2011).

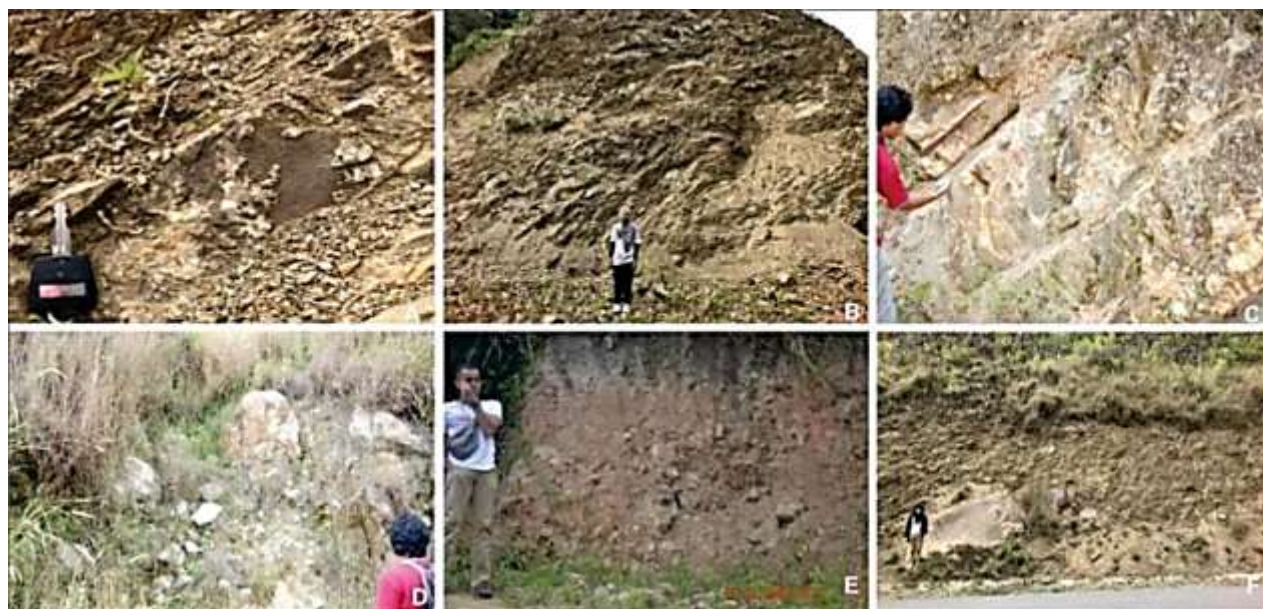
There are four (4) rocks unit underlying the study area namely Trusmi formation, Crocker formation, Pinosuk Gravel, and Colluvium deposit (alluvium) (Photo 1). Laboratory analysis found

that the Colluvium deposit is weak (19.52 MPa) by Lithological Unit Thickness, LUT method (Ismail Abd Rahim et al., 2009). The characteristics of Pinosuk Gravel which is almost like Colluvium (i.e., unconsolidated deposit and consists of rock block and matrix materials) assumed as a ‘weak’ rock unit also. The Uniaxial Compressive Test (UCT) was conducted on Trusmadi and Crocker formations rocks and found the strength to be medium (Table 2). Then, it concludes that the strength of rock units varies from ‘medium to weak’ and is prone to landslides or less resisting force.

**Photo 1** Moderately strong to weak rock units’ appearance. A& B- Sheared meta-arenite and meta-argillite (dark) of Trusmadi formation; C- Crocker formation sandstone; D- Pinosuk Gravel; E&F- colluvium deposits.

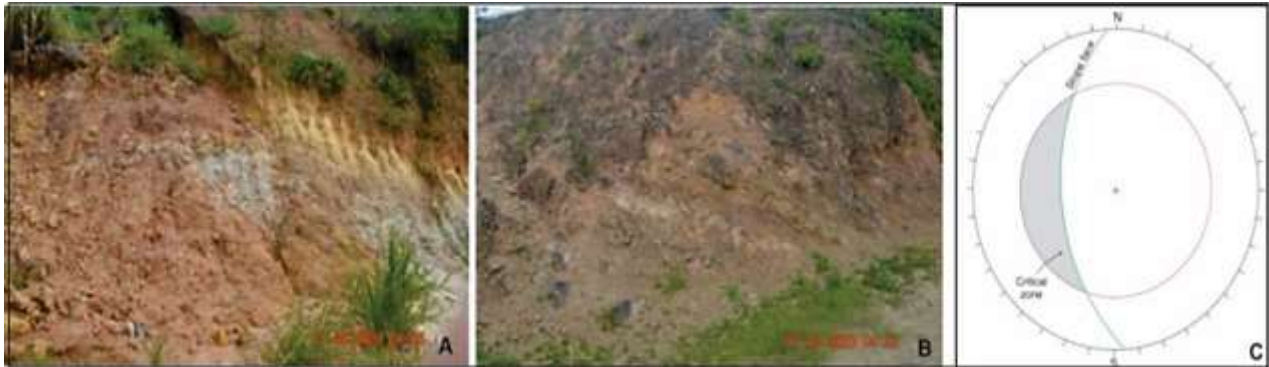
In the weathering process especially for class IV, the old discontinuity plane normally disappears. So, the discontinuity observation during the survey depends on relic structures on the limited outcrop. The effect of the weathering activity on discontinuities is the formation of planar failure in the Markland test (Figure 7C). Highly weathered Trusmadi formations (underlain Zen Garden Resort) are locally potential to produce a high concentration of kaolinite and illite. This clay easily absorbs water and expands. Then, facilitate mass movement by reducing the resisting force in slope-forming rock materials, especially during heavy or prolonged rainfall (Baba Musta, 2021).

**Figure 7** The weathered (class IV) rock unit. A- Crocker formation; B- Trusmadi formation; C- planar failure.

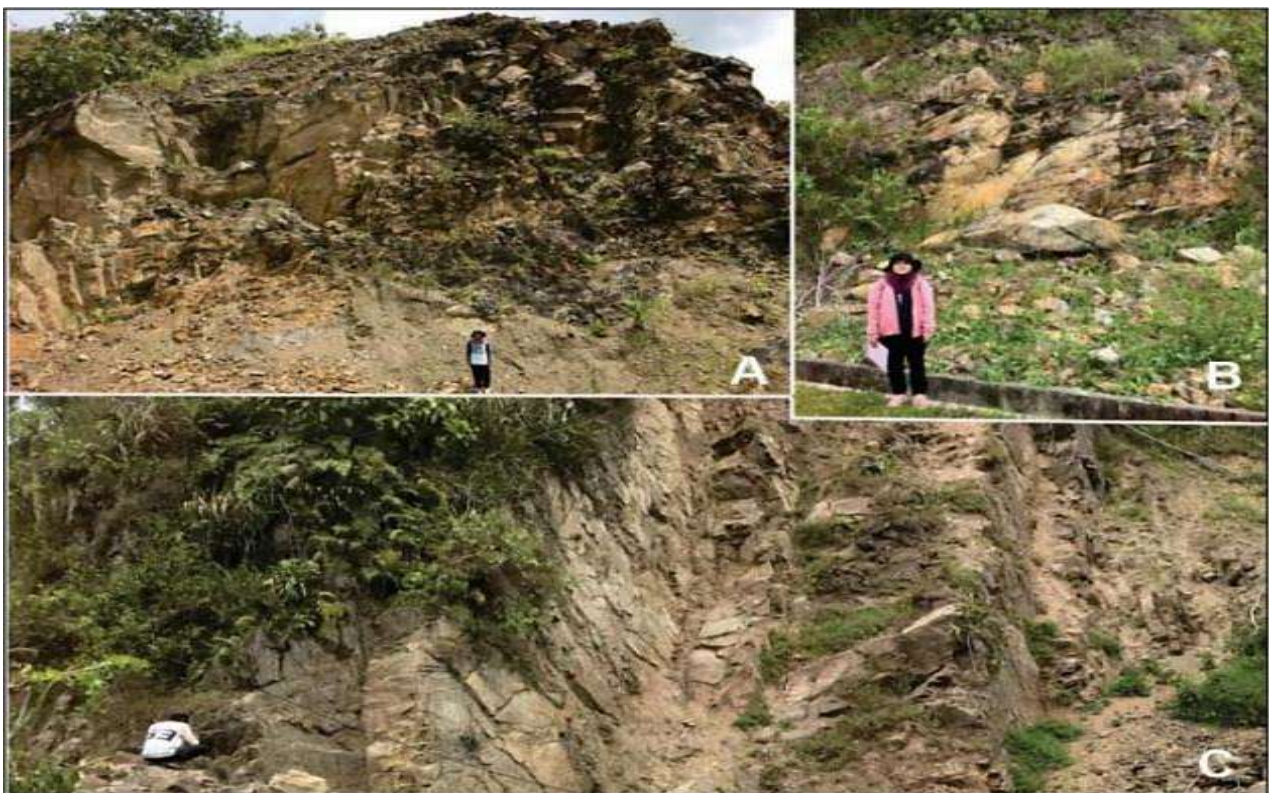
Field observation shows that the rock unit was highly jointed and sheared (Photo 2). The discontinuities are varied from four (4) to six (6) sets. Some as individually and some are intersected with other sets to ‘daylight’ on slope face to form planar, toppling, and/ or wedge types of mode of rock slope failures. These show that the occurrence of joint and shear planes has naturally caused landslides by decreasing resisting force for slope-forming rock materials.

**Photo 2** Fractured and sheared meta-sandstone of Trusmadi formation forming the wedge failures, toppling failure, and rock fall (A-C).

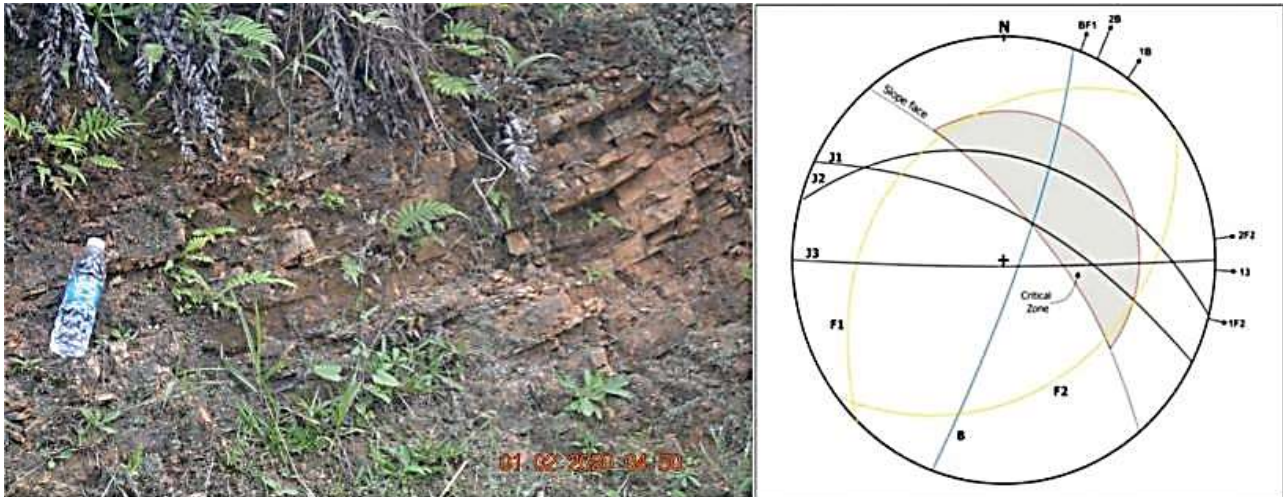
Adversely oriented discontinuities (bedding) or structural (fault) discontinuity with slope face have been observed in the study area. The first example is shown in Figure 8. This Trusmadi formation was cut by six (6) discontinuity sets including joint, bedding, and fault planes. The intersection of joint 1 (J1) and bedding (B) planes was ‘daylight’ on slope face or contributed to ‘unfavourable’ discontinuity orientation. This was causing the formation of potential wedge failure. This indicates that adversely oriented discontinuities are a naturally causal factor for landslides.

**Figure 8** Trusmadi formation's outcrop and wedge failure from Markland test representing adverse discontinuity orientation with slope face.

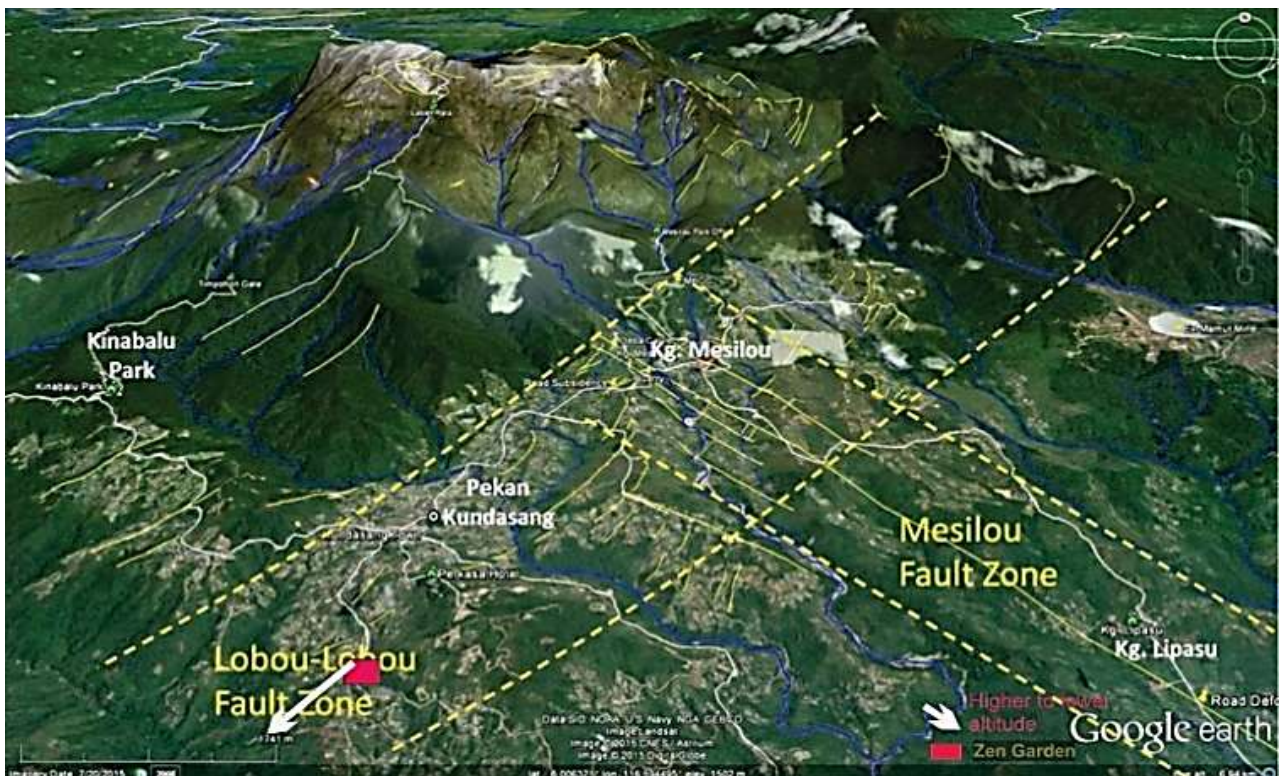
In general, the Kundasang area is situated at the intersection of major fault zones of the Quaternary ages as highlighted in Tjia (2007) (Figure 9). The study area is situated inside the northern part of Crocker Faults Zone, CFZ which is known as an oblique normal fault of Lobou-Lobou Fault Zone (LFZ). The slope face is facing the lower altitude of sg. Kayongang valley in LFZ and the movement of this fault has broken and fractured the bedrock along the fault line and slope toe (JMGM, 2012). This condition has been reducing toe support and shear strength (resisting force) but raising the driving force (plus the weight or gravity) of the slope forming rock material, especially during rainy days. Then, the adverse orientation of structural discontinuity has been causing a landslide-prone condition in the study area.

**Figure 9** Normal fault scarp (in yellow) trending NE-SW across the Kundasang- Mesilou areas. These faults are grouped under the Lobou-Lobou Fault Zone. White arrows show driving force direction). Adapted from Ismail Abd Rahim et al. (2015).

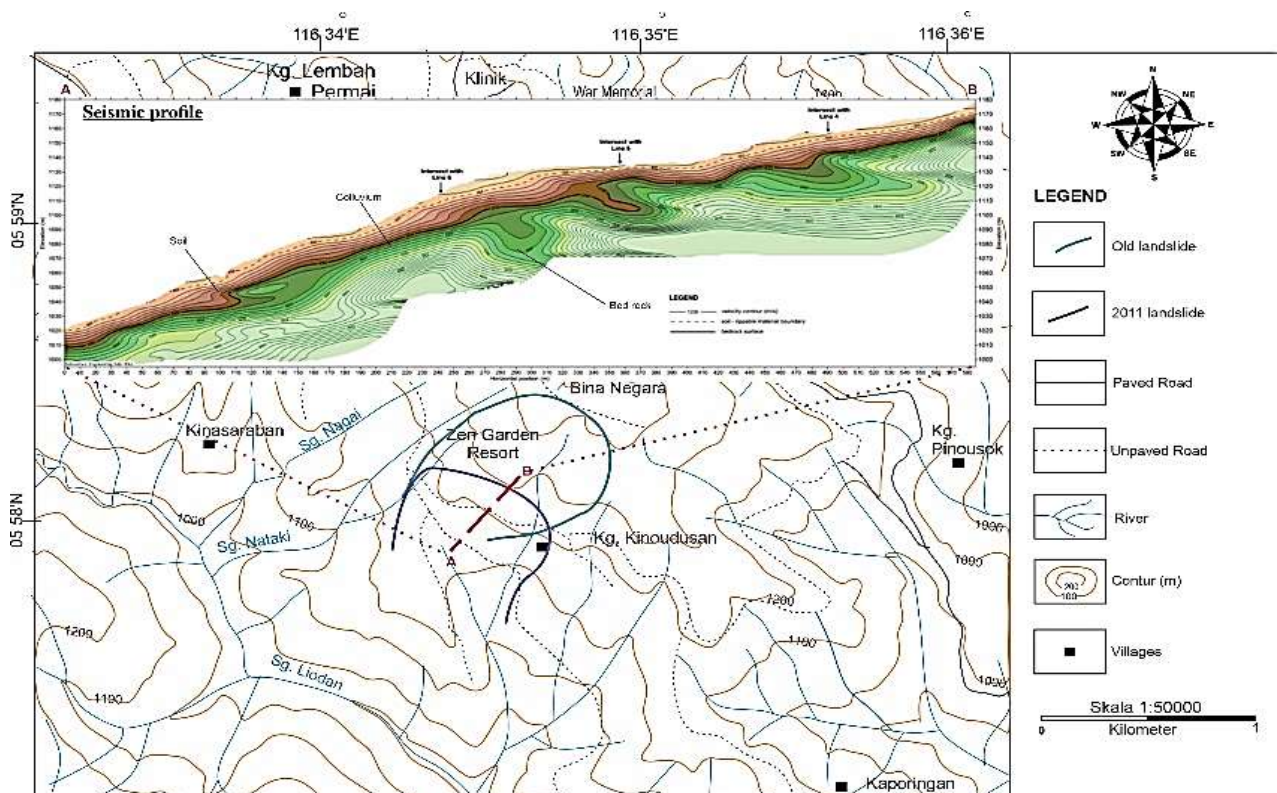
The thickness of Colluvium in the studied slope varies from 10-20m (Figure 10). The rainfall intensity during that event is only 1.54 mm/hrs. which is far from the suggested values (rainfall intensity of 3 to 4 mm/hr.) for the formation of a perched water table. But the daily rainfall ranges from 0.5 to 4.85 mm/hrs. for several days before the event may cause the water to percolate into colluvium and exceed the rate of seeping into bedrock. This condition forms a temporary perched water table in the Colluvium, and a downslope seepage force develops within the Colluvium. Excess pore pressures develop, the Colluvium becomes buoyant, the resisting forces are decreased, and landslides will occur (Turner, 1996; Kesseli, 1943).

Permeability contrasts within the bedrock may result in artesian conditions (Turner & Schuster, 1996). The water contains Colluvium (dark brown) and bedrock units (dark green), and artesian (dark brown greenish color) conditions are shown in Figure 10.

The seismic profile in Figure 10 also shows the thin Colluvium deposit and high-water table of less than 20m depth. This high-water table will allow fast saturation conditions and reactivation or/ and creation of sliding plane, sliding process or landslide.

**Figure 10** Seismic profile showing bed rock (Trusmi formation), colluvium and soil. The 10-20m thick colluvium deposit can reach field capacity condition and perched water table. The dark brown and green show the contrast in permeability between colluvium deposit and

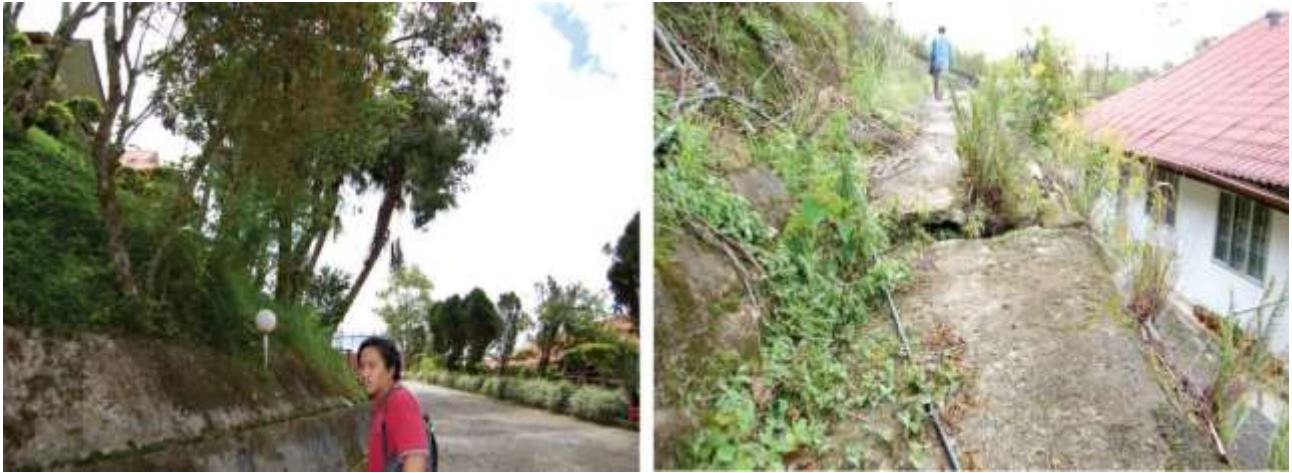
The purpose of excavating the slope and slope toe is to stabilize and protect slopes as well as provide accessibility. The slope face is normally excavated for optimum slope angle, to reduce erosion, infiltration, and weathering rates, and to control surface water (Photo 3). But improper excavation will result in causing slope failures. Such as inaccurate optimum slope angle, improper berm drains, infiltration, and surface water controls.

**Photo 3** Slope excavations. Construction of optimum slope angle, terrace, berm drain and shotcrete to increase resisting forces.

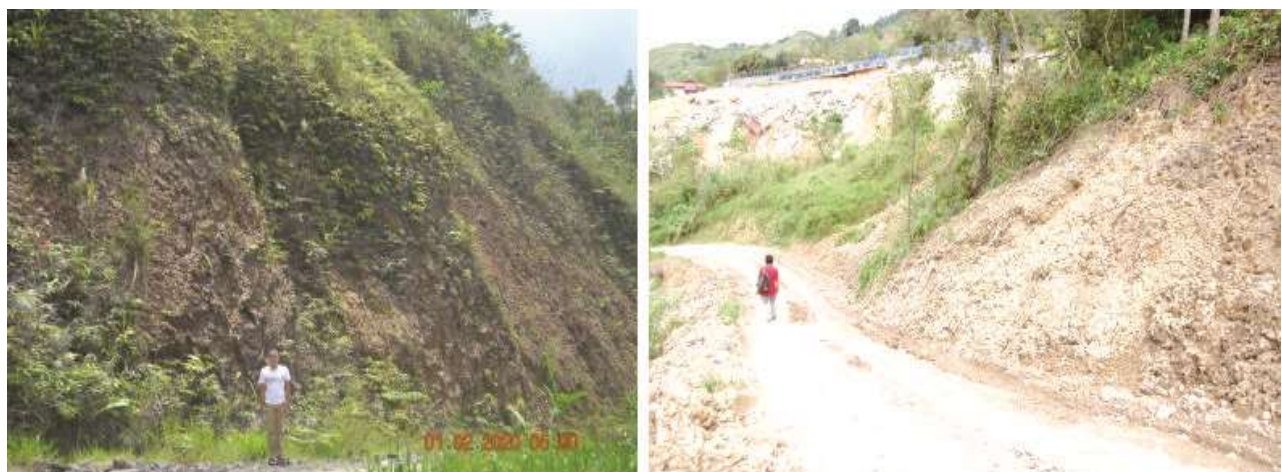
Slope toe excavation was conducted to provide facilities for the resort itself or local residence surroundings (Photo 4). But improper excavation on slope toe has caused slope failure due to loss of or reduction of resisting force for slope forming materials.

**Photo 4** Construction of minor roads at slope toe for the accessibility of the surrounding residents.

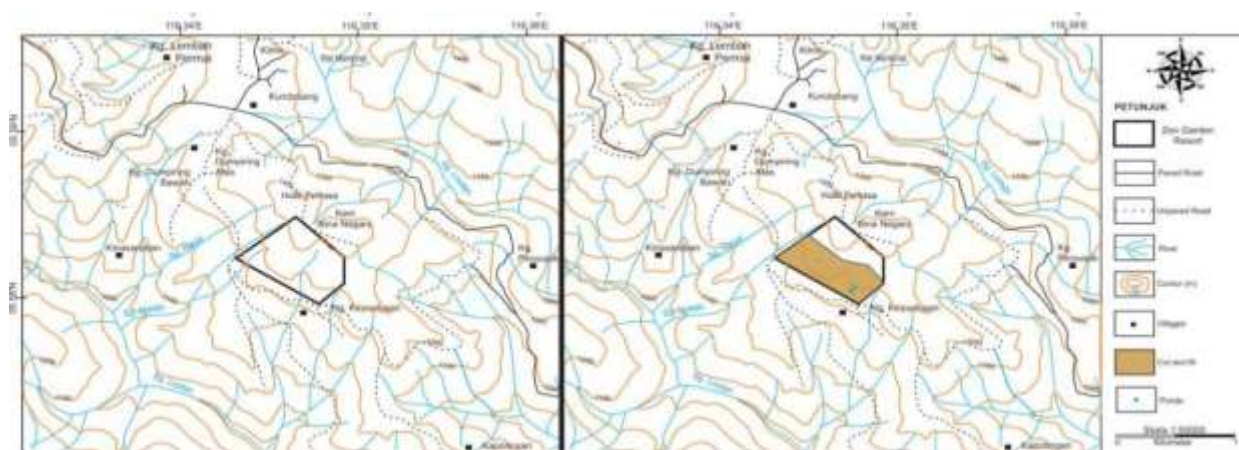
There are about two square kilometers have been cut and filled to design and build the facilities in Zen Garden Resort (Figure 11). The cut and fill materials on the original ridge topography area may also contribute to weakening the ground foundation in a long-term condition since water flow, soil, and rock condition were already disturbed and altered. These activities altered the slope faces and drainage patterns in that area. The slope cutting has risen the rate of weathering, erosion, and infiltration. These in turn were reducing the resisting force of the slope.

**Figure 11** Zen Garden Resort landslide area and cut and fill section. Some rivers were filled and altered for this development.

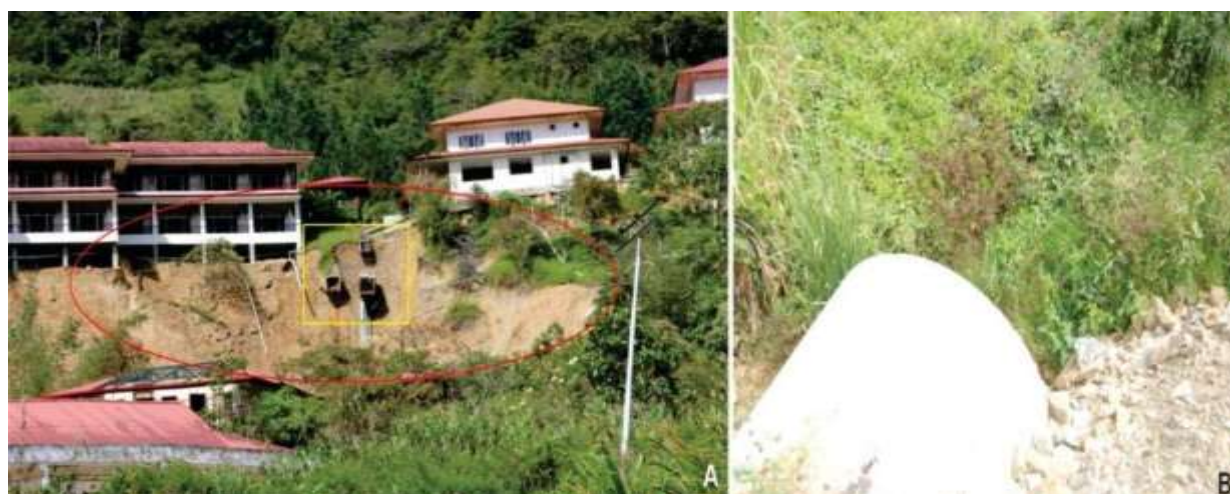
Filling the slope or an area such as a lower area, major, minor valleys or a reservoir into a flat area has been altering the natural environment, drainage pattern, or types (Photo 5A). These alterations were normally causing blockage and inappropriate recharge and discharge of water into the drainage system or reservoir (Photo 5B). These cut and fill activities have changed water balance or equilibrium then increasing the driving force on the slope face.

**Photo 5** A- Evidence of old drainage channel and landslide which has been cut (for foundation and building) and filled (red circle) and alteration of natural drainage by the construction of concrete drainage (yellow square). B- filling activity and changing natural drainage channel into the culvert.

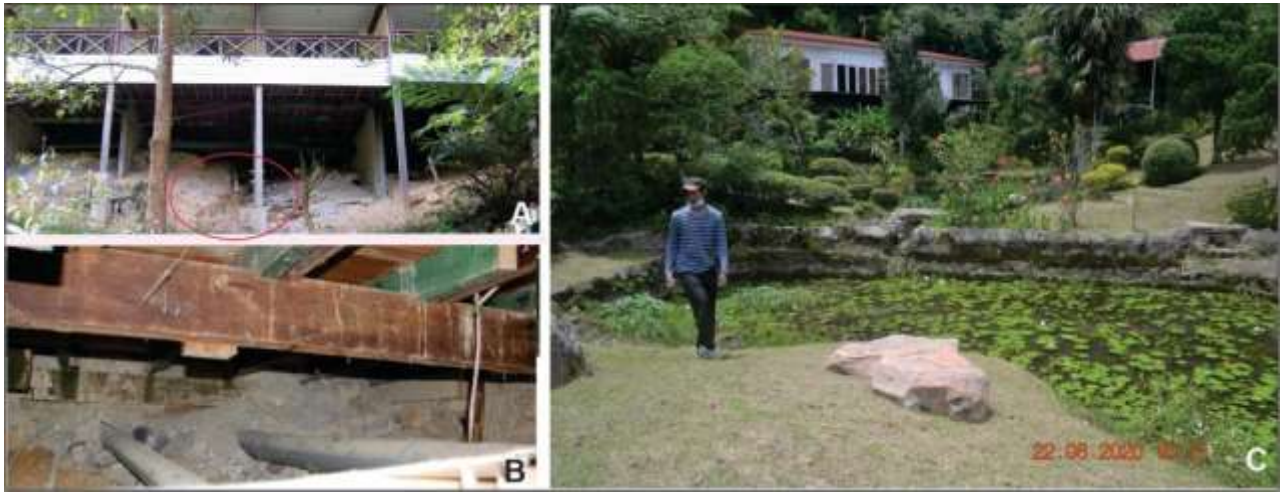
Subterranean drainage is a subsurface drainage system which is not seen from the surface. Normally subterranean drainage is made of PVC (Photo 6B) in various sizes or constructed of concrete (Photograph 6C). There is no landslide issue if this subterranean drainage is working. The problem is if the channel break or leakage (Photo 6A) then, subterranean erosion will occur. This leakage will erode the slope forming rock materials and finally reduce the resisting force.

**Photo 6** Subterranean erosion. A- water leakage (red circle) due to broken channel or connection failure: B- subterranean drain (PVC) that is connected to the river; C- a small pond that is connected by the subsurface concrete drain. This pond is believed to be a small old river channel that fills and alters into a subterranean concrete ditch.

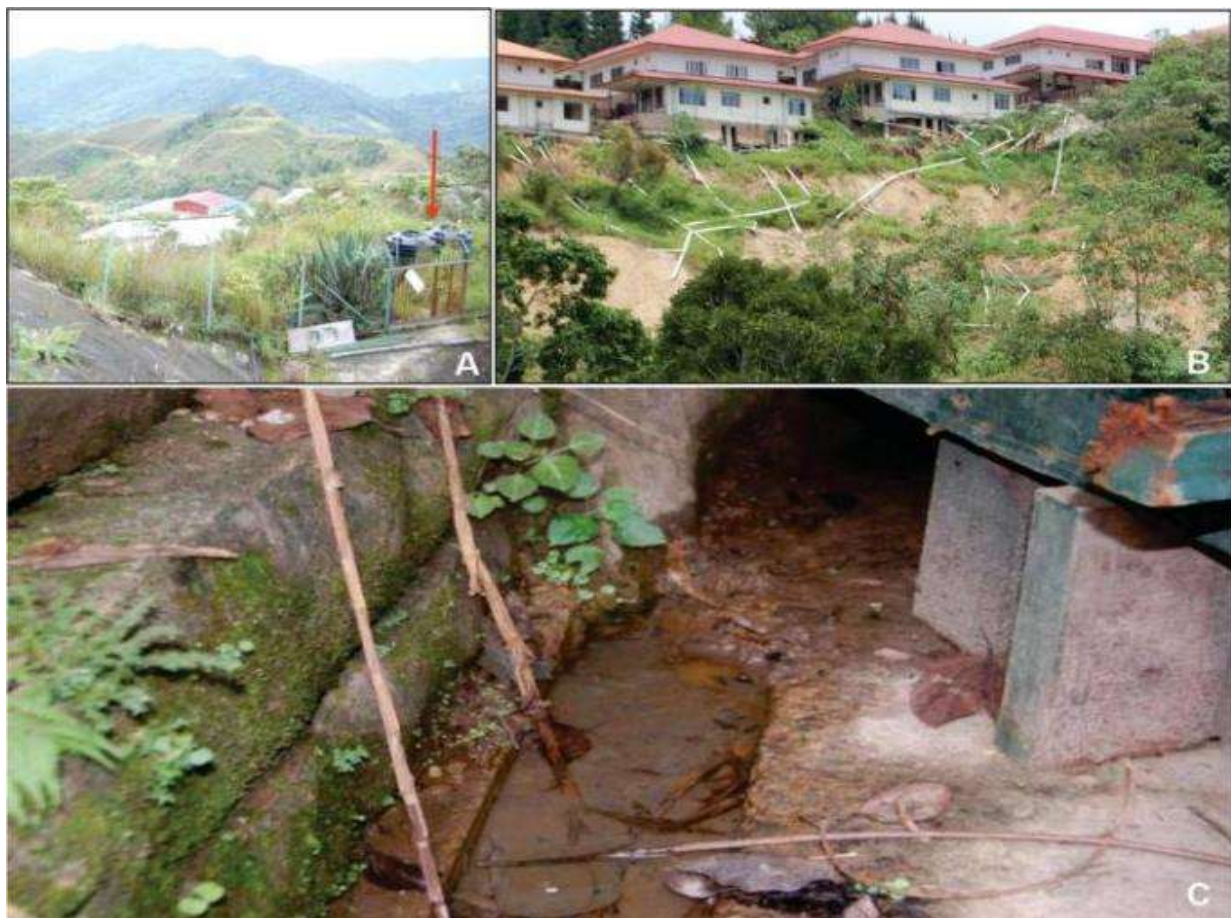
Kudasang is a highland area and doesn't have a proper water supply station except for collected from the natural spring water by Sabah Drainage and Irrigation Department, JPS. The activities or operation in Zen Garden Resort was conducted by using the water supply from JPS and collecting rainwater from Resort's personal tank. The photograph below shows the Resort water tank (in black color, Photo 7A) and irrigation system (Photo 7B)

The landslides become an issue if there is leakage in the tank and irrigation networks. This leakage will behave like rainwater that decreases the resisting force of rock-forming slope materials. The same condition will happen if a concrete ditch leaks by the occurrence of faults (Photo 7C).

**Photo 7** Water leakage from utilities. A- water tank to reserve water supply; B- part of irrigation or drainage system around this Resort; C- concrete ditch filled with water shows a fault (?) form fracture.

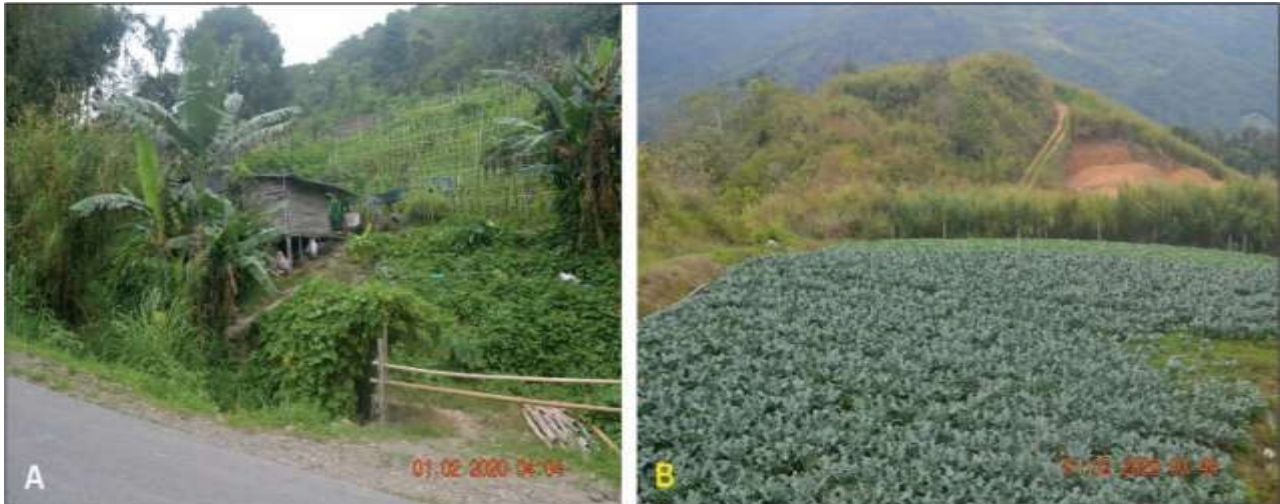
Agricultural activity is still can be seen today (Photo 8). The land clearance has been causing the rate of erosion, weathering, and infiltration (runoff) to increase but reducing resisting force for slope forming rock material and contributing to landslides occurrence.

**Photo 8** Vegetation removal or deforestation and planting activity by the locals.
