SLOPE STABILITY ASSESSMENT OF THE TEMBURUNG FORMATION ALONG BEAUFORT-TENOM RAILWAY, SABAH

ABSTRACT. This paper discusses the stability and to propose preliminary rock cut slope protection and stabilization measures for the Oligocene to Late Miocene Temburung Formation along the Beaufort-Tenom railway, Sabah. Nine (9) slopes were selected for this study. Geological mapping, discontinuity survey, kinematic analysis and prescriptive measures were used in this study. Result of this study conclude that the mode of failures are wedge, planar, circular and complex types. Gunite, soil nails, wire mesh, weep holes, subsurface drainage, slope reprofiling, terracing and surface drainage are proposed stabilization and protection measures for the slope in study area.

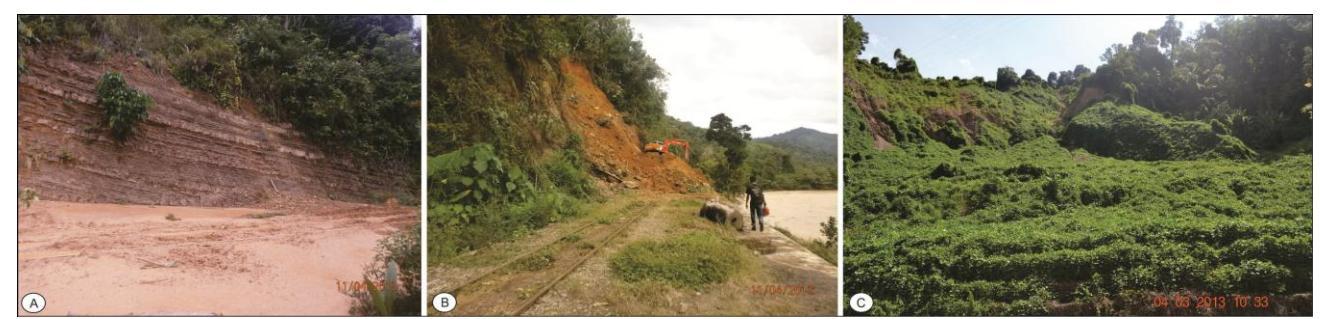
The occurrence of slope failures at km 130.1 and 112 on 9 April 2013 (Photograph 1A and 1B) and km 123.8 of Beaufort-Tenom railway on 7 April 2008 (Photograph 1C) with 2 mortality has become issues for this study. These three (3) slope failures was happened in Temburung formation. Then, this study was conducted only in Temburung formation. Temburung formation is characterized by intense jointing and sheaing, small poligonal block shape $(1\text{ cm}^3 - 1\text{ m}^3)$ and irregular blocks type. To evaluate the rock slope stability, 9 cut rock slopes have been selected and identified as Slope 1, 2, 3, 4, 5, 6, 7, 8 and 9, respectively. The locations of cut rock slopes in the study area are shown in Figure 1.

Photograph 1. Slope failure. A - km 130.1 (2013); B – km 112 (2013); C – km 123.8 (2008).

Combination of potential wedge failue with others potential and possible planar and wedge failures contribute to the formation of complex failures in slope 3, 5, 7, 8 and 9. Combination of planar and wedge failures in slope 5 was identified as the factor for huge complex failure on 7 April 2008.

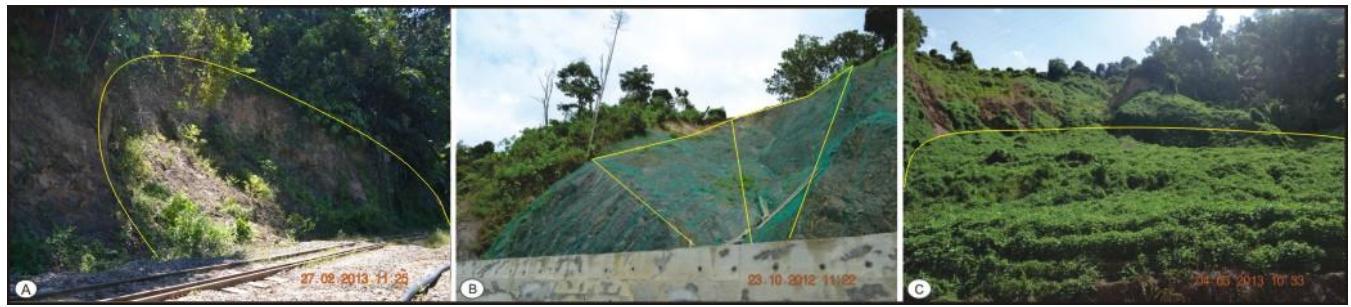
Observed instability features on the slope face are planes circular failure (Photograph 4A), wedge failure (Photograph 4B) and complex failures (Photograph 4C), debris deposits and rock blocks. Results of the Markland test are shown in Figure 2 and Table 2. The potential modes of failures are wedge, circular, planar and complex failures.

Photograph 3. Slope failures. A – circular failure; B – wedge failure; C – complex failure.

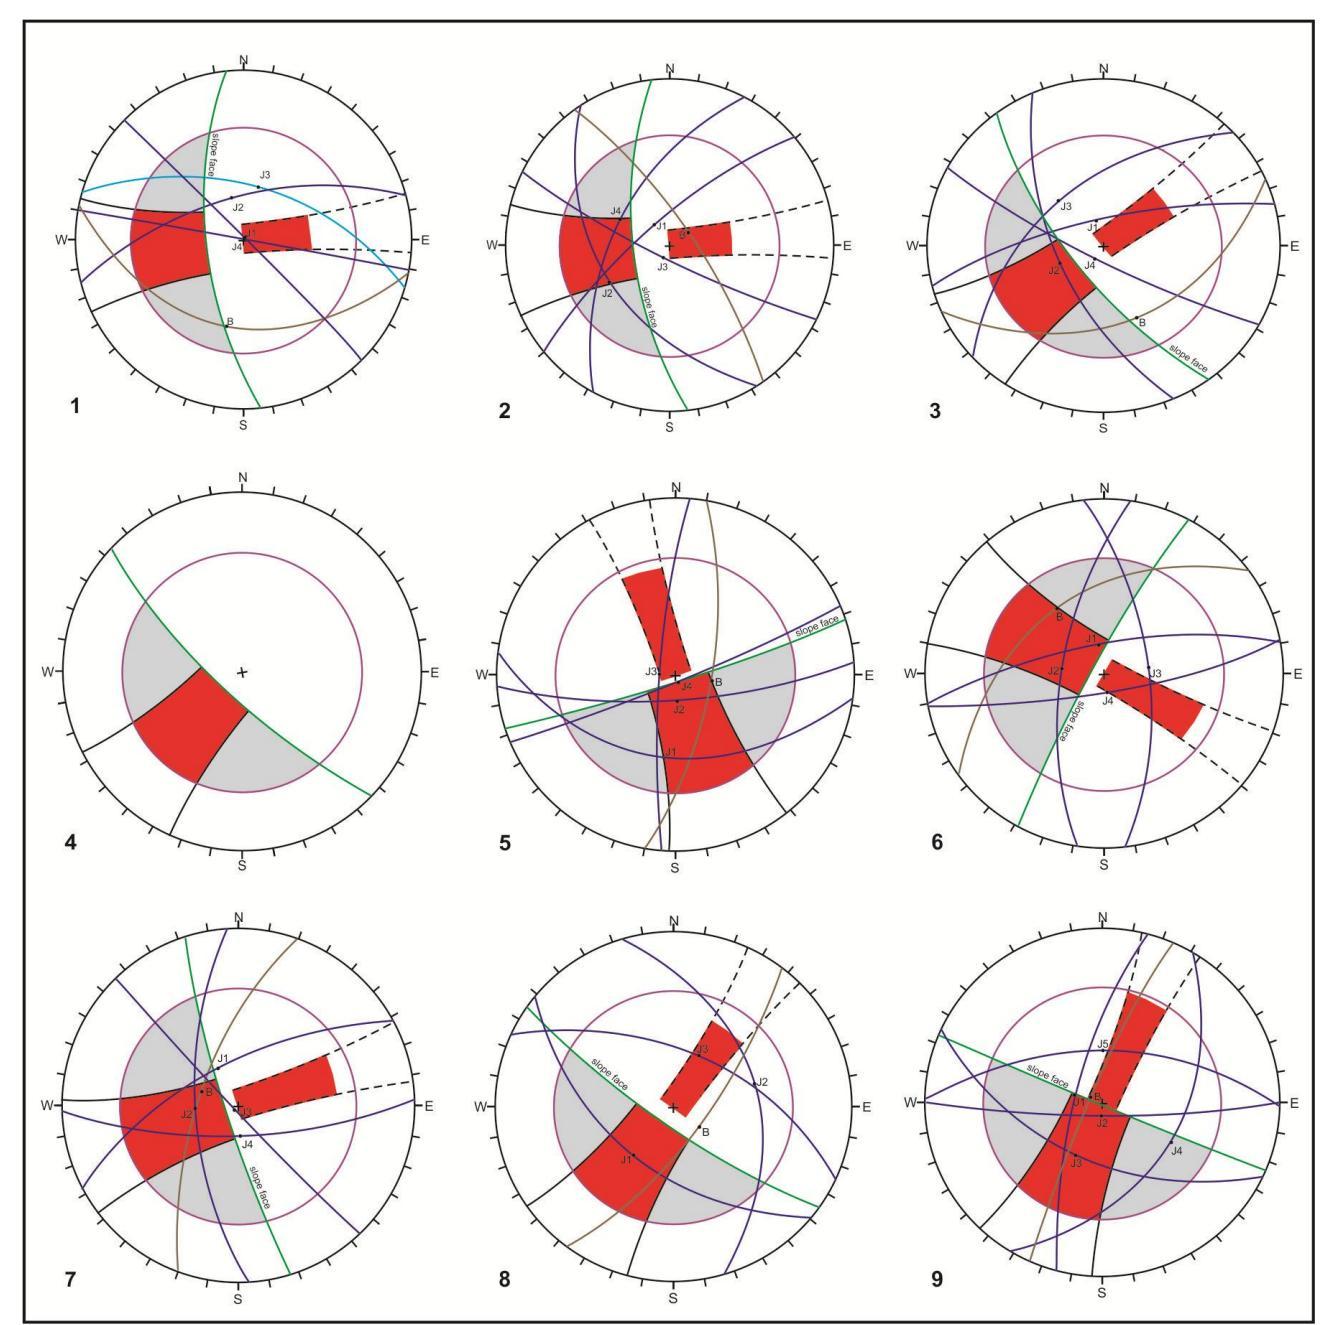
Figure 2. Markland test for slope 1 (S1) to slope 9 (S9). B- bedding; J1- joint 1; J2- joint 2; J3- joint 3; J4- joint 4; J5- joint 5; BJ3 – intersection of bedding and joint 3; BJ2 – intersection of bedding and joint 2; J1J2 – intersection of joint 1 and joint 2; J1J3 – intersection of joint 1 and joint 3; BJ1 – intersection of bedding and joint 1; J3 – discontinuity plane of joint 3.

Intersection of J4 with J2, J1 with B, J1 with J2, J1 with J4 and J3 with B in slope 1, 5, 6, 7 and 9 contributes to the formation of wedge failures, respectively. The wedge failure is only possible in slope 2 because the differences between intersection lines and dip direction of slope faces for J4 with J1, J4 with J2 and J1 with J2 more than 20° but combination between these wedge failures will potential to form complex failure. Occurrences of

individual joint that parallel and daylight on slope face is also contribute to the formation of planar failures in slope 3, 5, 7, 8 and 9.

Based on kinematic analysis, all slopes need to be reprofiling as well as instalation of weep holes due to the occurrences of shale layers. In the slopes where shale thicker then sandstone layers, subsurface drainage is required to reduce pore pressure behind slope face such as slope slope 2, 4, 5 and 6. Wire mesh is another option for most of the slopes as a retention structure and avoiding the rock block falling on the rail track except thick shale slope of slope 4. Dominan shale slopes of slope 2, 4, 5 and 6 can be protected from weathering, runoff and water infitration by guniting. High slopes of slope 1, 2, 3, 6, 7, 8 and 9 must be terraced and surface drainage to control runoff (erosion) and water infiltration. Soil nails and retaining structures need to be installed in thick shale and fails slopes such as slope 4, 5 and 6.
