GEOLOGICAL INPUTS FOR LANDSLIDE HAZARD IDENTIFICATION (LHI) IN THE TRUSMADI FORMATION SLOPES, SABAH, MALAYSIA

Rodeano Roslee, Sanudin Tahir, Baba Musta & S. Abd. Kadir S. Omang

ABSTRACT. *This paper describes the importance of geological engineering inputs to landslide hazard occurrences in the Trusmadi Formation slopes, Sabah, Malaysia. The Trusmadi Formation regionally consists of two major structural orientations NW-SE and NE-SW. It consists mostly of dark grey shale with thin bedded sandstone, typical of a turbidite deposit. This unit has been subjected to low grade metamorphism, producing slate, phyllite and meta-sediment as well as intense tectonic deformation producing disrupted or brecciated beds. Quartz veins are quite widespread within the joints on sandstone beds. The shale is dark grey when fresh but changes to light grey and brown when weathered. The weathered materials are unstable and may experience sliding due to high pore water pressure, steep, hummocky or rugged slopes and intensively geomorphologic processes. Engineering properties of fifty five (55) soil samples indicated that the failure materials mainly consist of poorly graded materials of silty clay soils

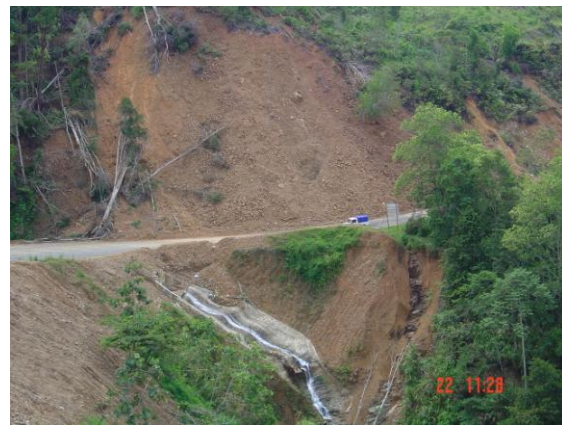
Figure 4. Photograph showing the settling soil block suffers from fracturing, stumping or flowing considerable lateral movement along the slip plane of the down slope (Location: KM 140 (S3))

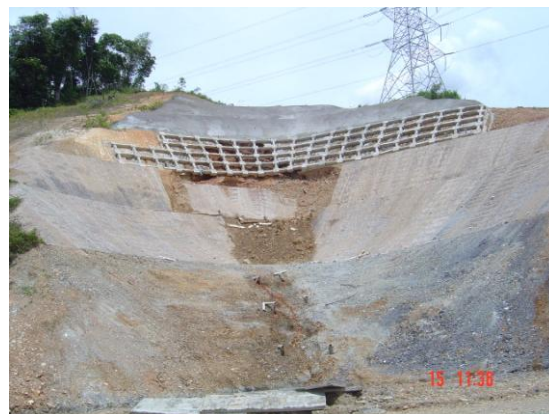
Figure 6. Damaged of slope physical state due to improper monitoring system

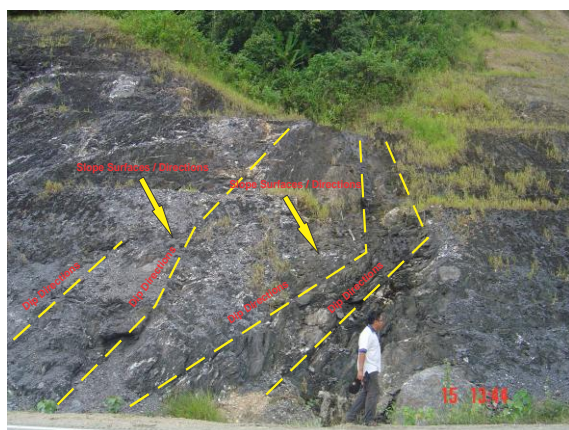
Figure 7. Slopes cut parallel to the strike and steeper than the dip of the day lighting planes then lead to landslide

In terms of the regional geologic setting, the effect of faulting activity can be observed in the study area. This was confirmed by the existence of transformed faulted material consisting of angular to sub angular sandstone fragments, with fine recrystallined quartz along the joint planes, poorly sorted sheared materials and marked by the occurrence of fault gouge with fragments of slate, subphyllite and slickensided surfaces (Figure 3). Highly fractured and sheared of the Trusmadi Formation indicates the result from long history of tectonic activities; most of faulting shears exist within the interbedded sandstone-shale and sandstone-slate-phyllite. Breaks and fractures were developed by shearing stresses were caused the rapid disintegration and weathering of the rocks into relatively thick soil deposit (Figure 4). As a corollary to this, in rock bodies, the surface roughness of joint are generally smooth to rough planar (Figure 3). A relatively smooth surface decreases the frictional resistance then increasing possibility of landslide hazard occurrences in the study area. Apart from that, field observation indicated that too many cut and filled slopes were designed without taking account input of geological interest. For example most of the slopes were designed too steep ($> 60^\circ$) (Figure 5), lack of monitoring on proper drainage system and slope physical state (Figure 6) and most of the slope cutting surface is parallel to the strike direction of the slate bedding orientation (Figure 7).

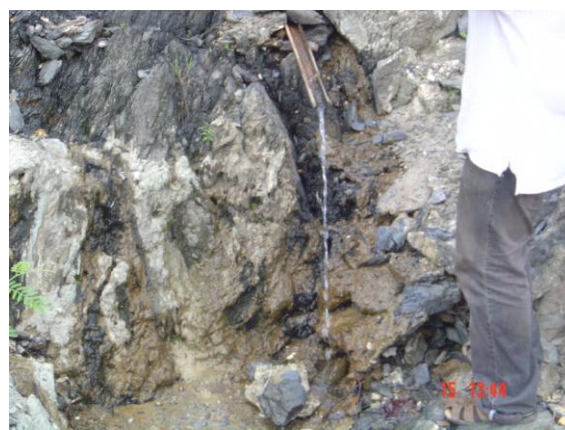
Figure 8. Water seepage/spring on the slope area. Intermittent sliding from this spot will lead to the major slope failure
