SLOPE STABILITY ASSESSMENT OF THE TEMBURUNG FORMATION ALONG BEAUFORT-TENOM RAILWAY, SABAH

ABSTRACT. This paper discusses the stability and to propose preliminary rock cut slope protection and stabilization measures for the Oligocene to Late Miocene Temburung Formation along the Beaufort-Tenom railway, Sabah. Nine (9) slopes were selected for this study. Geological mapping, discontinuity survey, kinematic analysis and prescriptive measures were used in this study. Result of this study conclude that the mode of failures are wedge, planar, circular and complex types. Gunite, soil nails, wire mesh, weep holes, subsurface drainage, slope reprofiling, terracing and surface drainage are proposed stabilization and protection measures for the slope in study area.

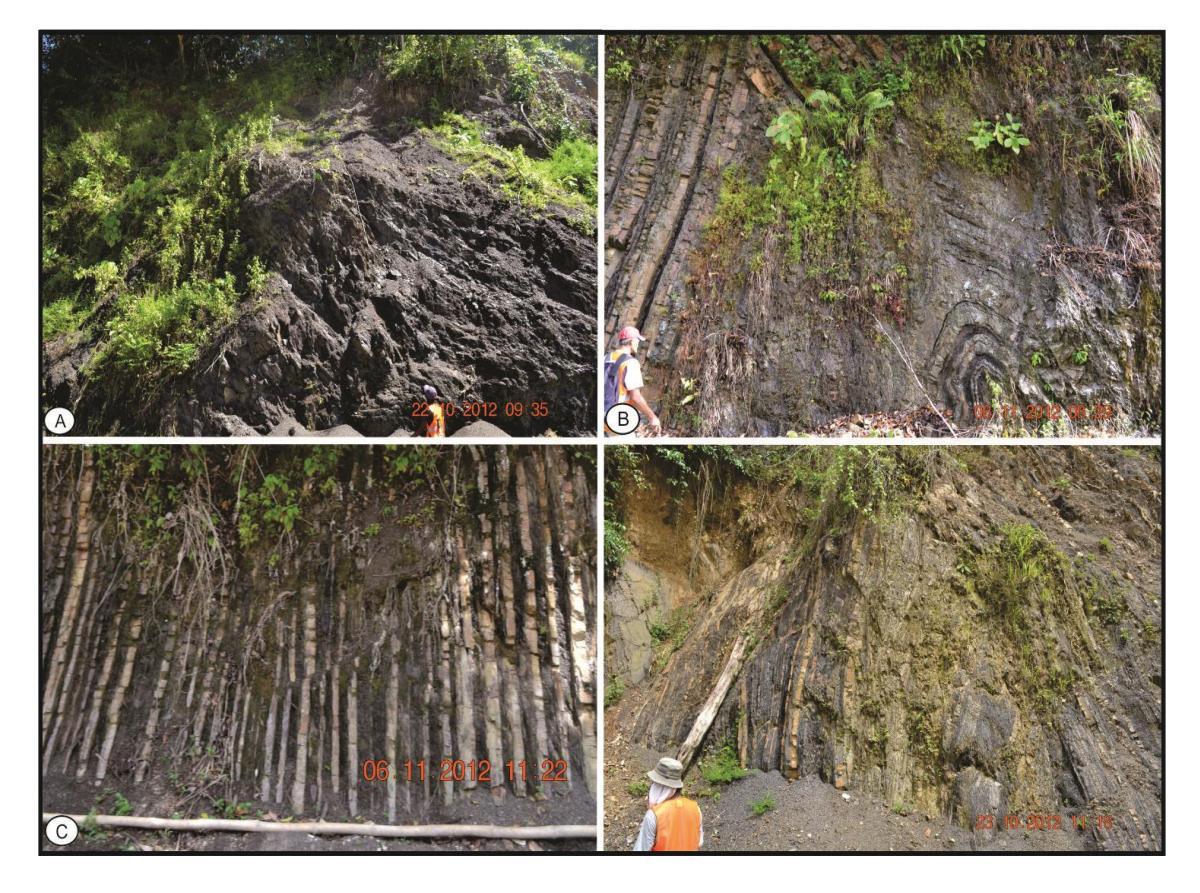
The Temburung formation was deposited by the age range from Oligocene to Early Miocene (Sanudin & Baba, 2007). The Temburong Formation is slightly different compare to Crocker Formation. It is composed of thick shale unit (Photograph 2A) and interbedded shale and sandstone unit with 3:1 (Photograph 2B), 1:1(Photograph 2C) and 1:3 (Photograph 2D) ratios.

Photo 2. Lithological unit of the Temburung formation. A- thick shale unit at S4; Binterbedded 3:1 shale and sandstone unit at S5; C- interbedded 1:1 shale and sandstone unit at S9; D- interbedded 1:3 shale and sandstone unit at S9.
