**THE 2011 ZEN GARDEN LANDSLIDES: TRIGGER AND CAUSAL FACTORS**

**ABSTRACT:** *The Zen Garden Resort and its surrounding area are part of the “Kundasang Landslide Complex” and were experiencing reactivation of old landslides on 10 April 2011. Consequently, more than 80 room units of the resort, ten buildings, homes, and local roads were destroyed, uplifted, and damaged as well as disrupted day traffic. About 500m in length and 200m in width of the slope area were slides for 25m. The vertical fall movement in the head section of the landslide is 25m. There is no direct relationship between the 2015 Ranau earthquake and with earlier rotational clay slide of the 2011 Zen Garden Resort landslide. The causing and triggering factor for landslides are generally varied and are always characterized as region-specific and site-specific. Thus, this study was conducted to unravel the triggering and causal factors for the rotational clay slide of the 2011 Zen Garden Resort landslide. The methodology consists of desk study, remote sensing study, geological mapping, geodynamic mapping, laboratory, and data analysis. This study found that the landslides were triggered by prolonged moderate to occa

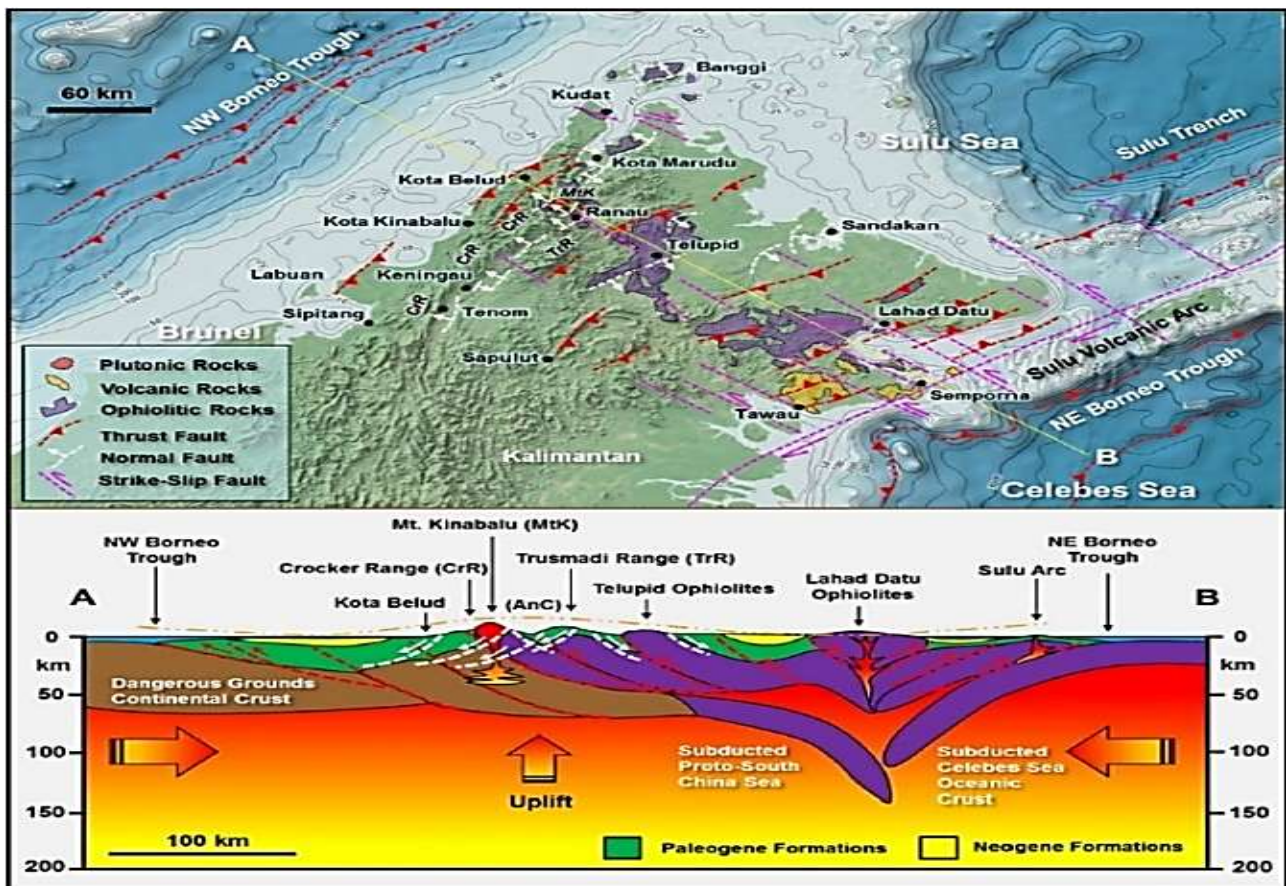
**Figure 6** Tectonic cross-section of Sabah showing post-collision collapse due to gravity sliding producing deep-seated normal fault (white line) in response to significant thickening and uplift of the Crocker Range upper crust. A- northwest; B-southeast (adapted from Tongkul, 2015).

The uplift belt or tectonic plate collision zone is continuing to compress and produce high-land areas around Crocker Range including the study area in Kundasang. This high elevation has been reducing the stability of the slopes. The higher the area, the steeper the slope and the less stable the slope. The natural tectonic uplift by collision has caused the slope to decrease in resisting force and become landslide prone.
